MCP2510 Rev. AA Silicon Errata Sheet

The MCP2510 parts you have received conform functionally to the Device Data Sheet (DS21291C), except for the anomalies described below.

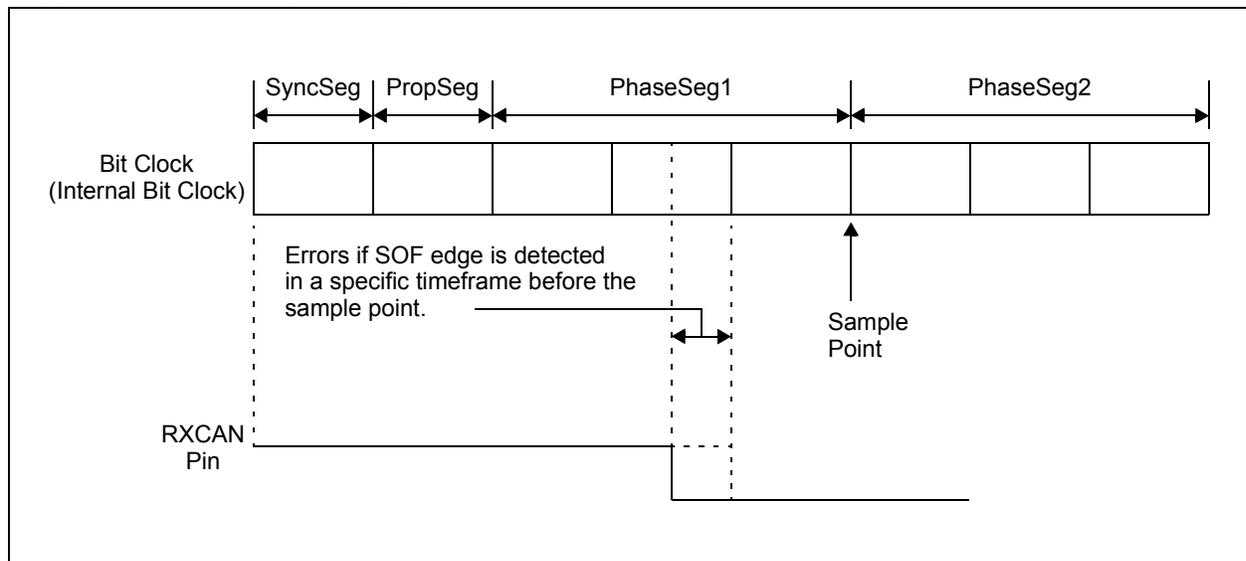
FIGURE 1: HARD SYNCHRONIZATION

A receive error will occur when the MCP2510, as a receiver, detects a SOF (recessive-to-dominant) at a certain position before the sample point. As alluded to earlier, each node operates asynchronously to its own bit timing which is a function of the oscillator. During a bus idle, the nodes do not have any recessive-to-dom-

Figure 1 illustrates the window in which the MCP2510 will mis-sample the SOF and generate an error later in the message. This Window of Susceptibility (WS) occurs 1TQ before the sample point and varies in width depending on the Baud Rate Prescaler (BRP) and the number of Time Quanta (TQ) in the bit and is discussed in detail later.

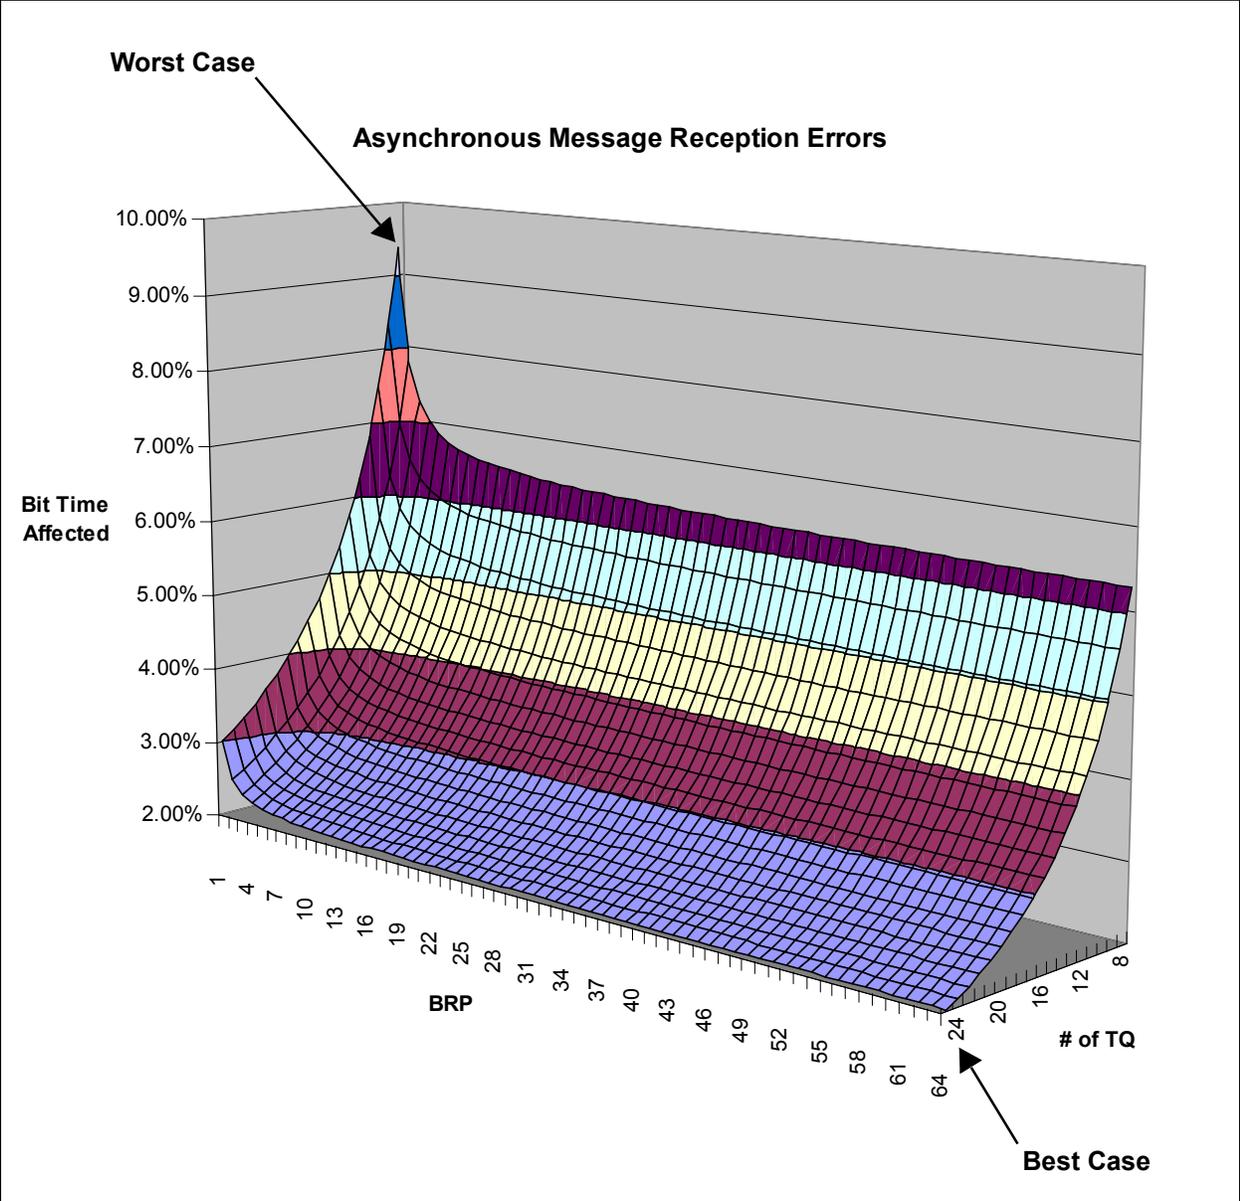
FIGURE 2: AFFECTED BIT TIME

As Figure 1 illustrates, there is a small timeframe within a bit time in which a recessive-to-dominant edge will cause the SOF to be incorrectly sampled. This window of Susceptibility as a percentage of the bit time is a function of the Baud Rate Prescaler (BRP) and number of Time Quanta (TQn) and is defined as:

Figure 2 graphs the WS (Bit Time Affected) for all of the BRP and number of TQ settings. As the graph shows, the worst case WS occurs when the MCP2510 is configured to TQ = 8 and BRP = 1. In this case, the percentage of the bit time affected is about 9.3%. This means that, providing sufficient oscillator drift has occurred during bus idle, there is a 9.3% probability that the MCP2510 will incorrectly sample the SOF and generate an error frame. (See item 2 below).

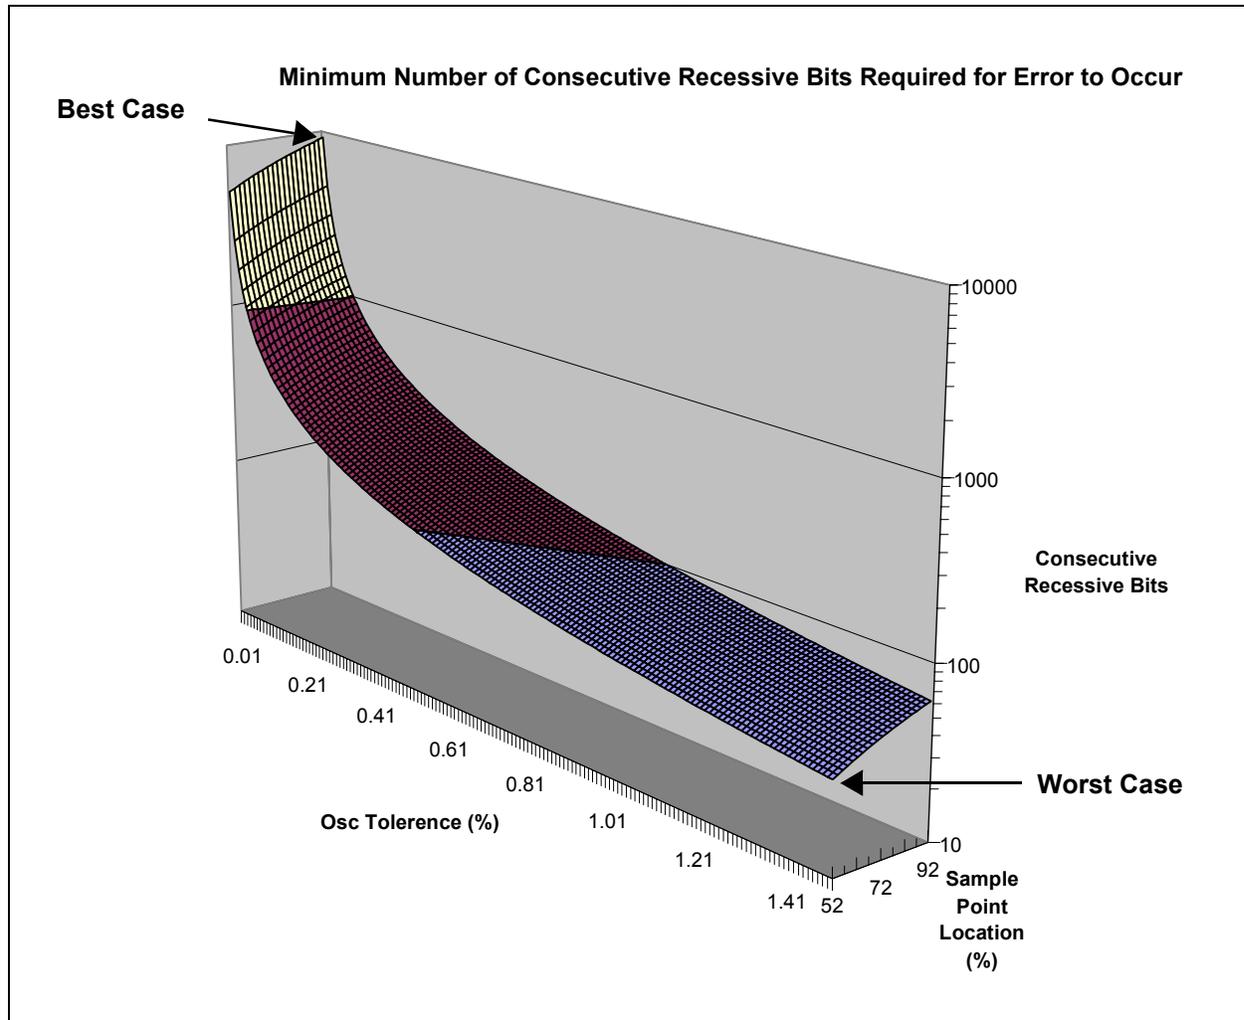
FIGURE 3: CONSECUTIVE RECESSIVE BITS REQUIRED TO ENABLE PROBABILITY

During long bus idle times, CAN nodes tend to get out of synchronization due to less than perfect oscillator tolerances. Eventually, the nodes may get far enough out of synchronization to allow the SOF to occur in the WS of the MCP2510's internal bit time, causing an error.

Two factors must be known to calculate how long it will take for the nodes to get far enough out of synchronization to enable the probability of a node incorrectly sampling the SOF. The two factors are the oscillator tolerances and the sample point position within the bit time. Figure 3 charts the number of consecutive recessive bits required before the probability of mis-sampling is activated. The chart uses oscillator tolerances from 0.01% (100 ppm) for crystal oscillators to 1.50% (15000 ppm) for ceramic resonators.

It is possible to virtually eliminate the potential for false errors, even in very light bus loads with long bus idle times, simply by using crystal oscillators with low ppm tolerances and manipulating the bit timing.

Using a 100 ppm crystal puts the consecutive recessive bit requirement to activate the probability at approaching 10,000 bit times (20 ms).

1. #TQ = 8, BRP = 2.
This puts the probability approaching **8%**
2. #TQ = 16, BRP = 1.
This puts the probability around **3.5%**
